**BUREAU OF SHIPS GROUP
TECHNICAL INSPECTION REPORT**

**OPERATION CROSSROADS.
U.S.S. BLADEN (APA63).**

TEST BAKER CUT. 8

DIRECTOR OF SHIP MATERIAL
JOINT TASK FORCE ONE

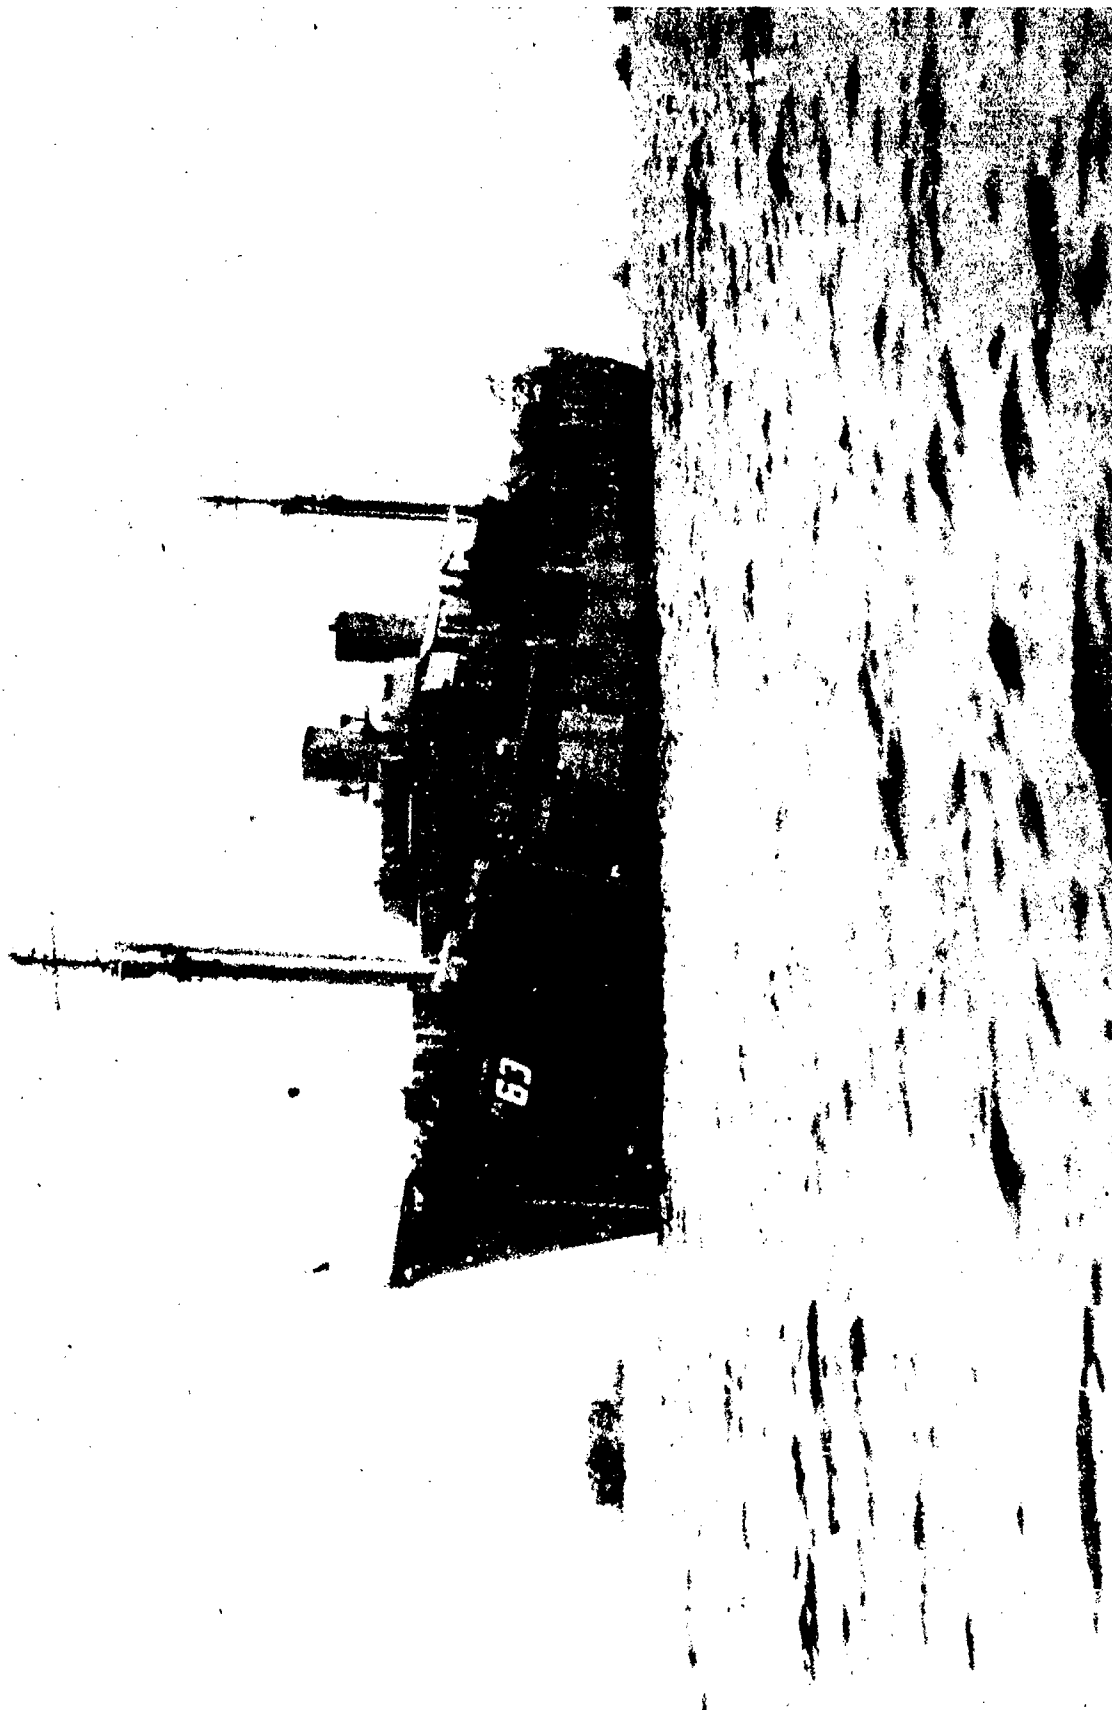
BB-CR-227-501-93. View off the port bow before Test B.

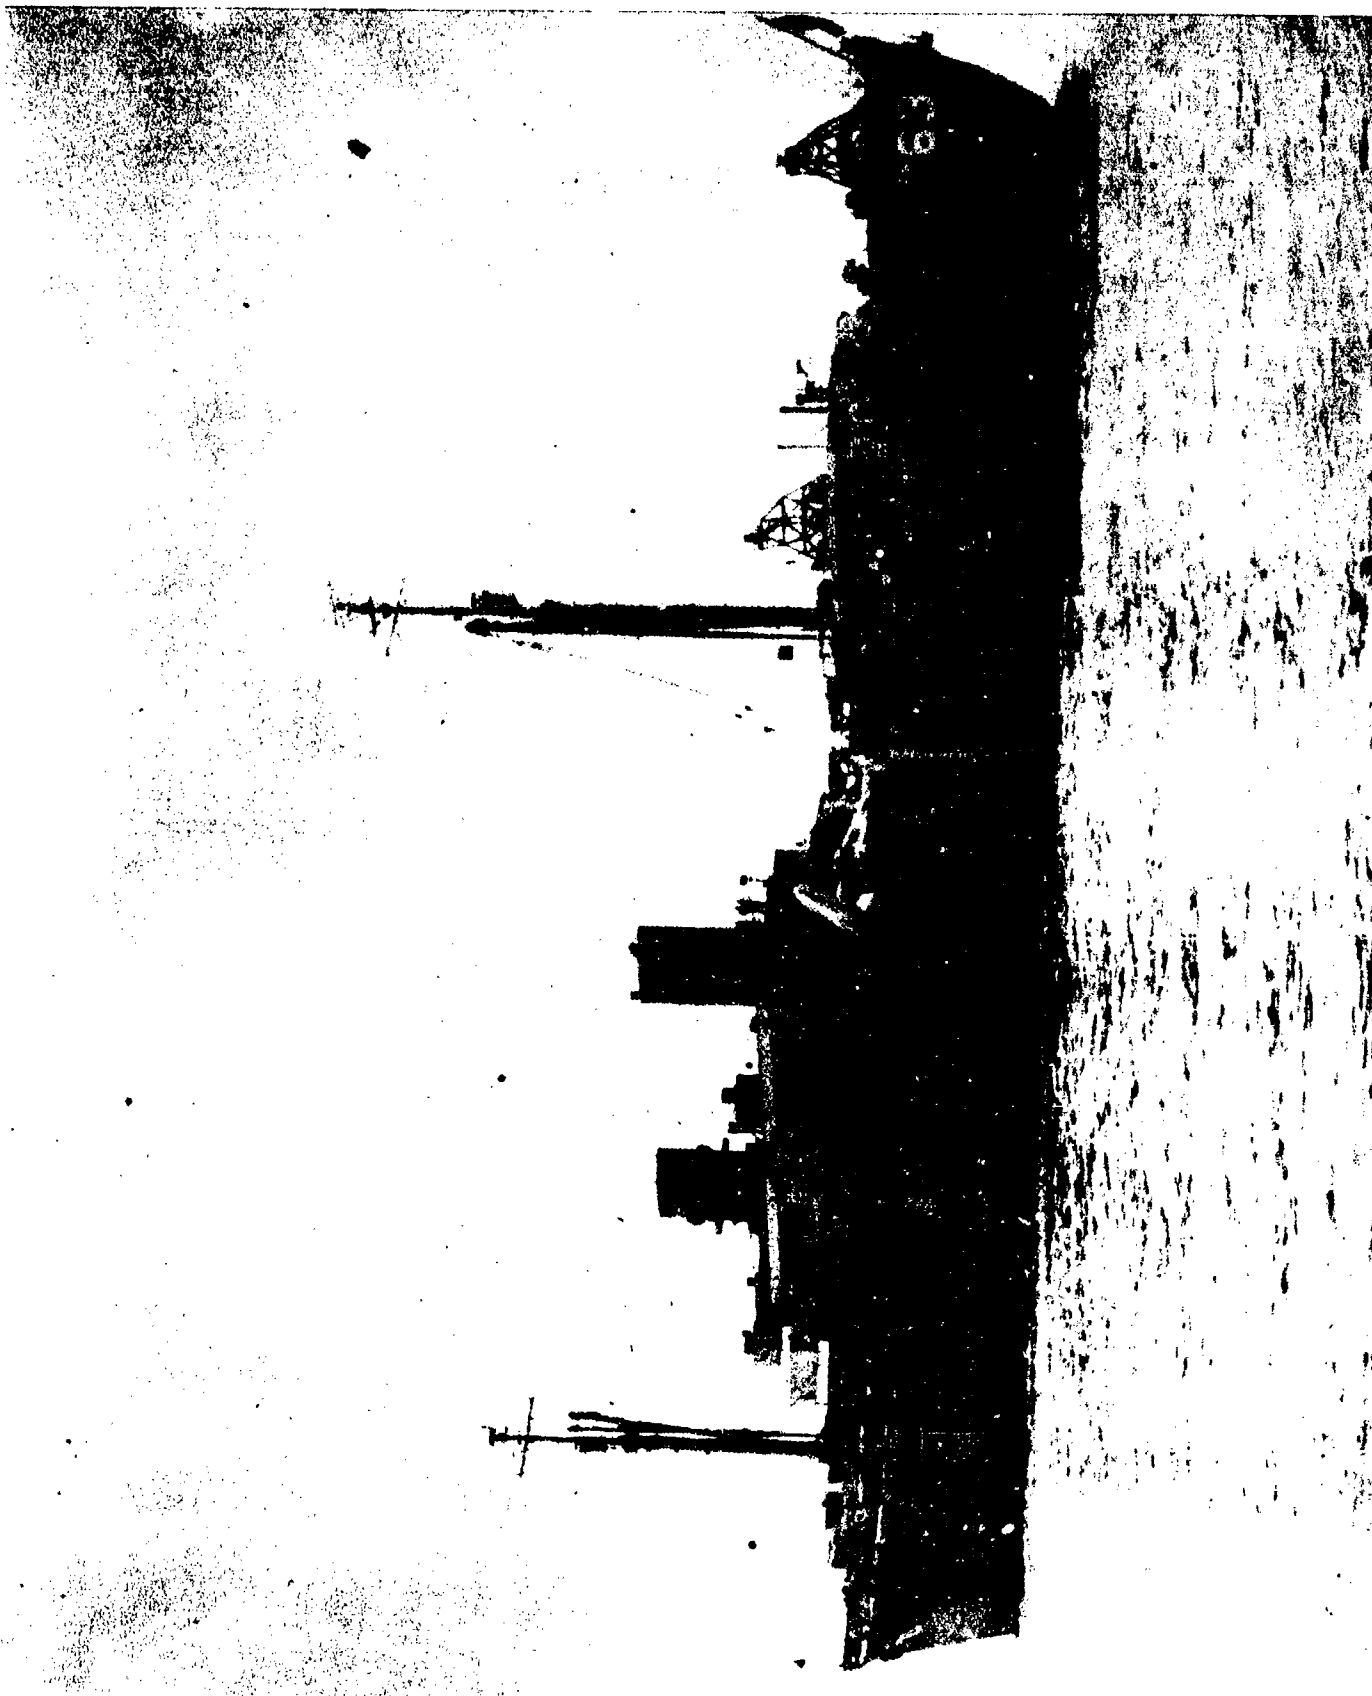
BB-CR-227-501-95. View off the port quarter before Test B.

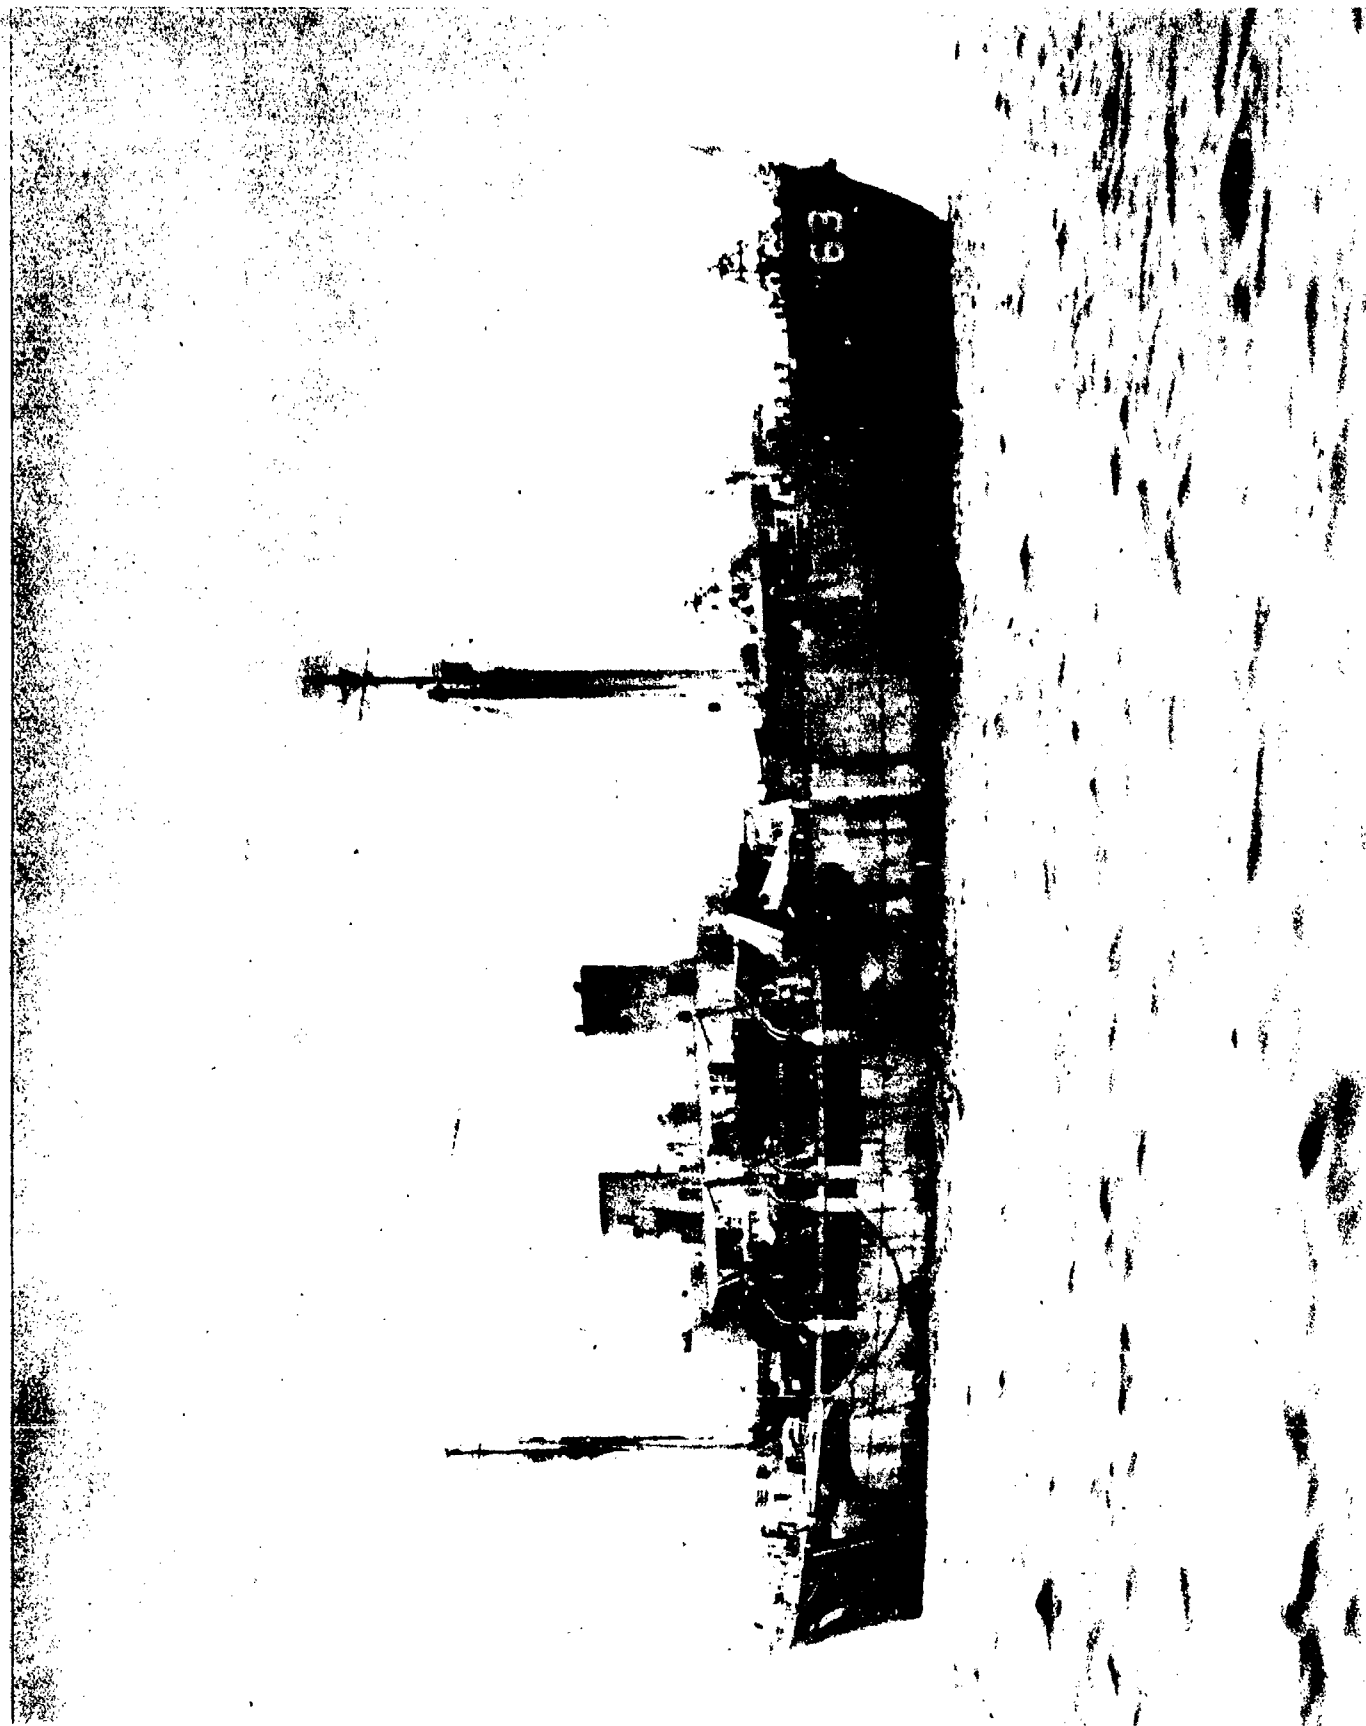
An athwartships canvas awning at the after end of the 03 deck was torn loose from the securing lashings at the inboard end and bent the 1 3/4 standard pipe outboard corner stanchions.

AB-CR-227-289-10. View off the port quarter after Test B.

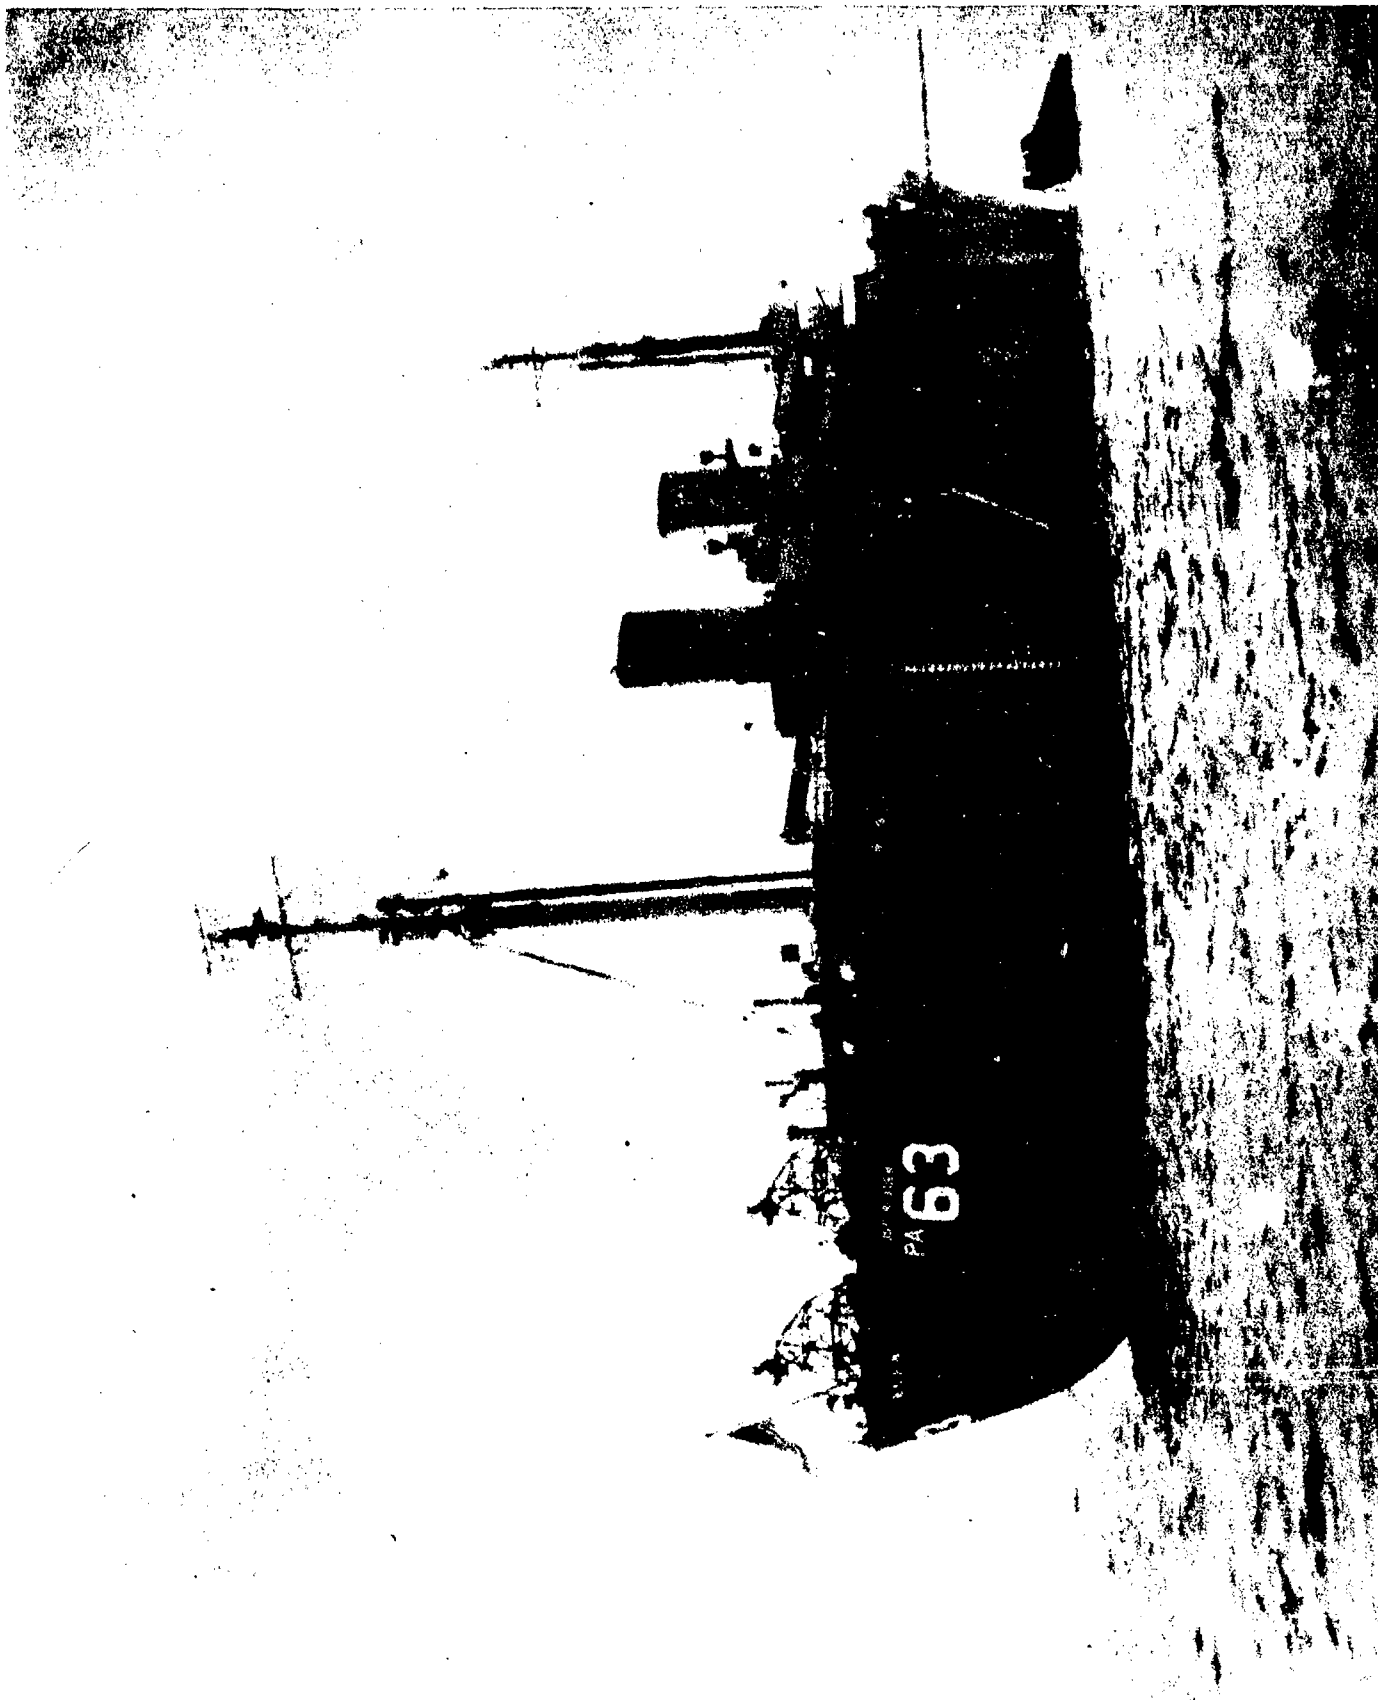
BB-CR-227-501-89. View off the starboard quarter before Test B.

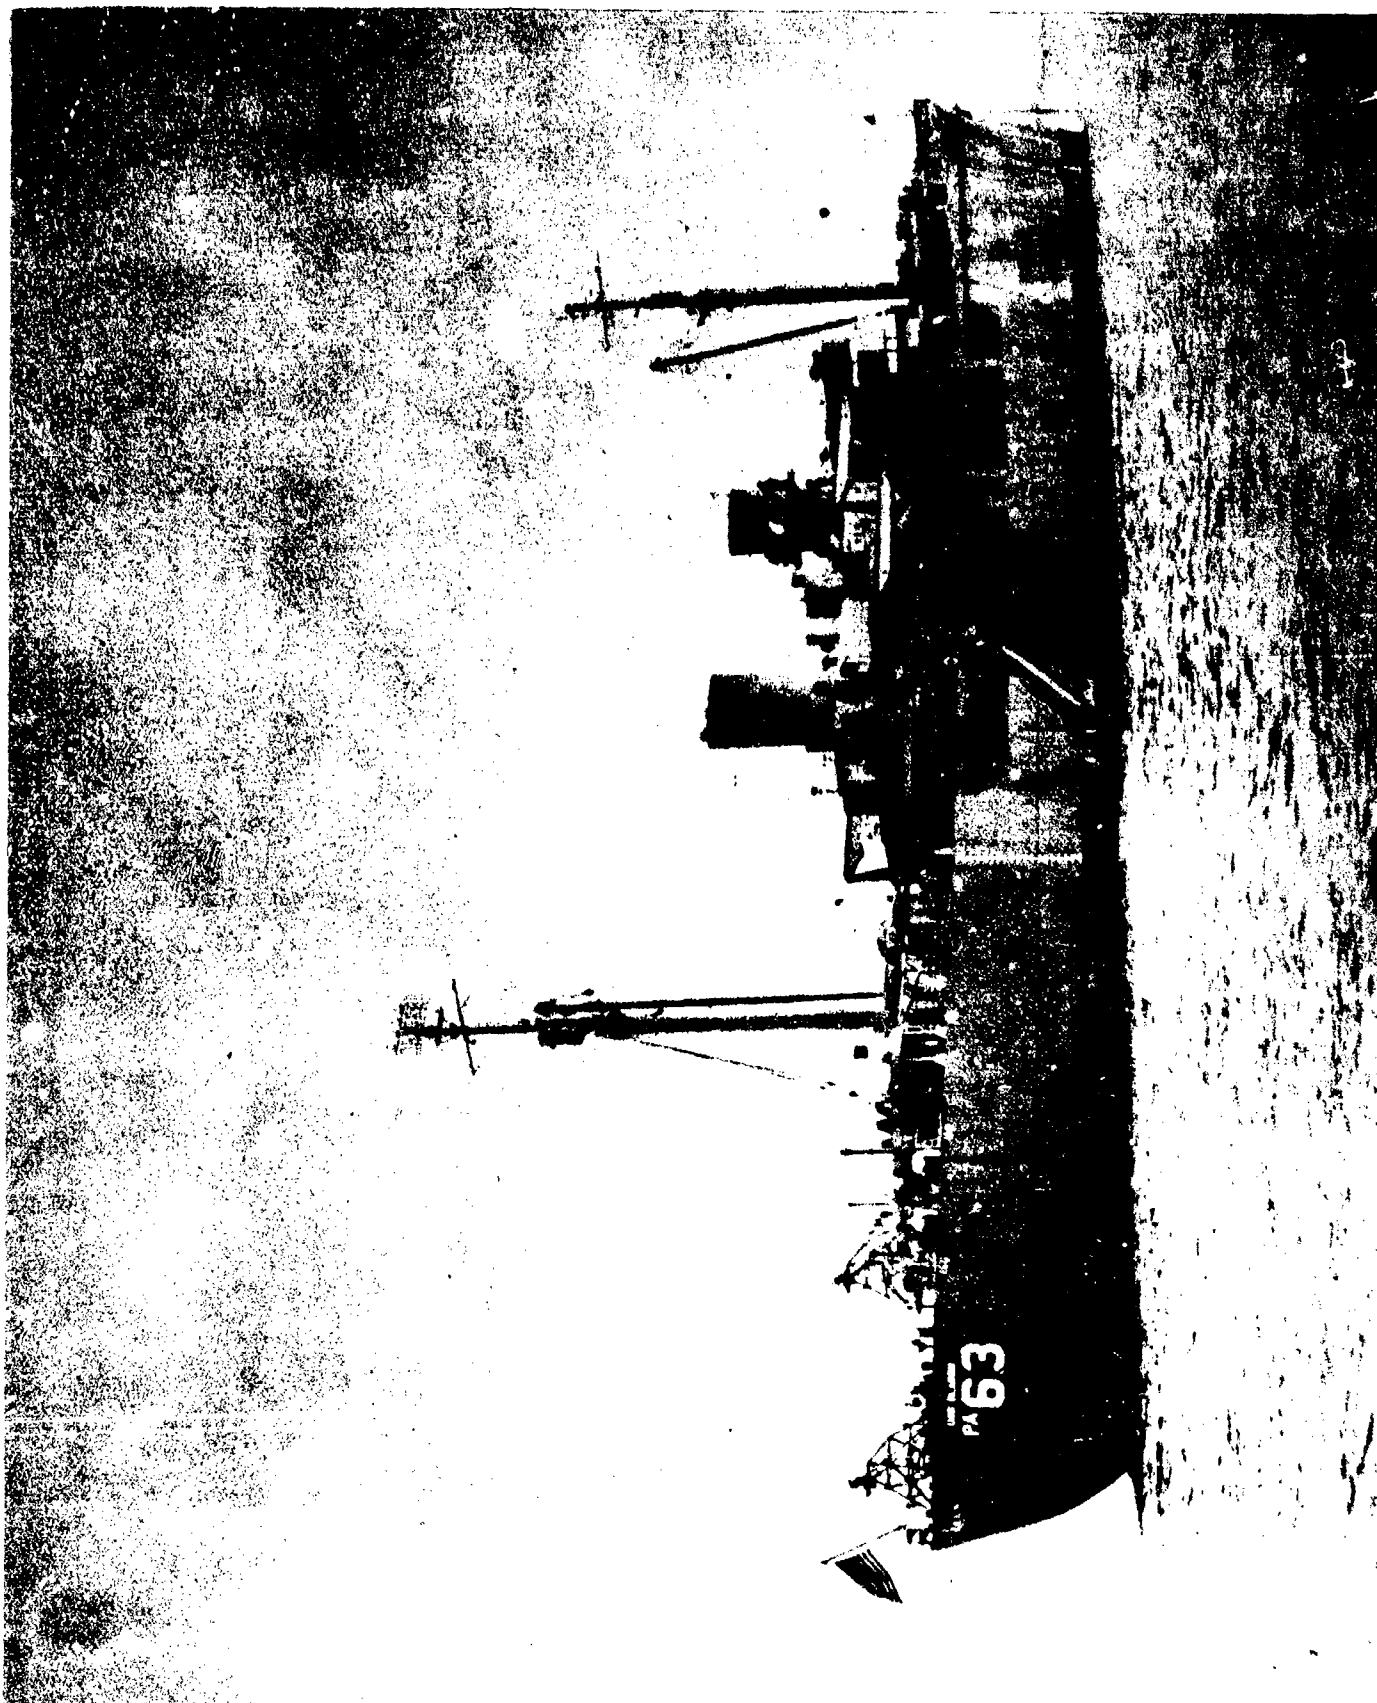
AB-CR-227-289-16. View off the starboard quarter after Test B.

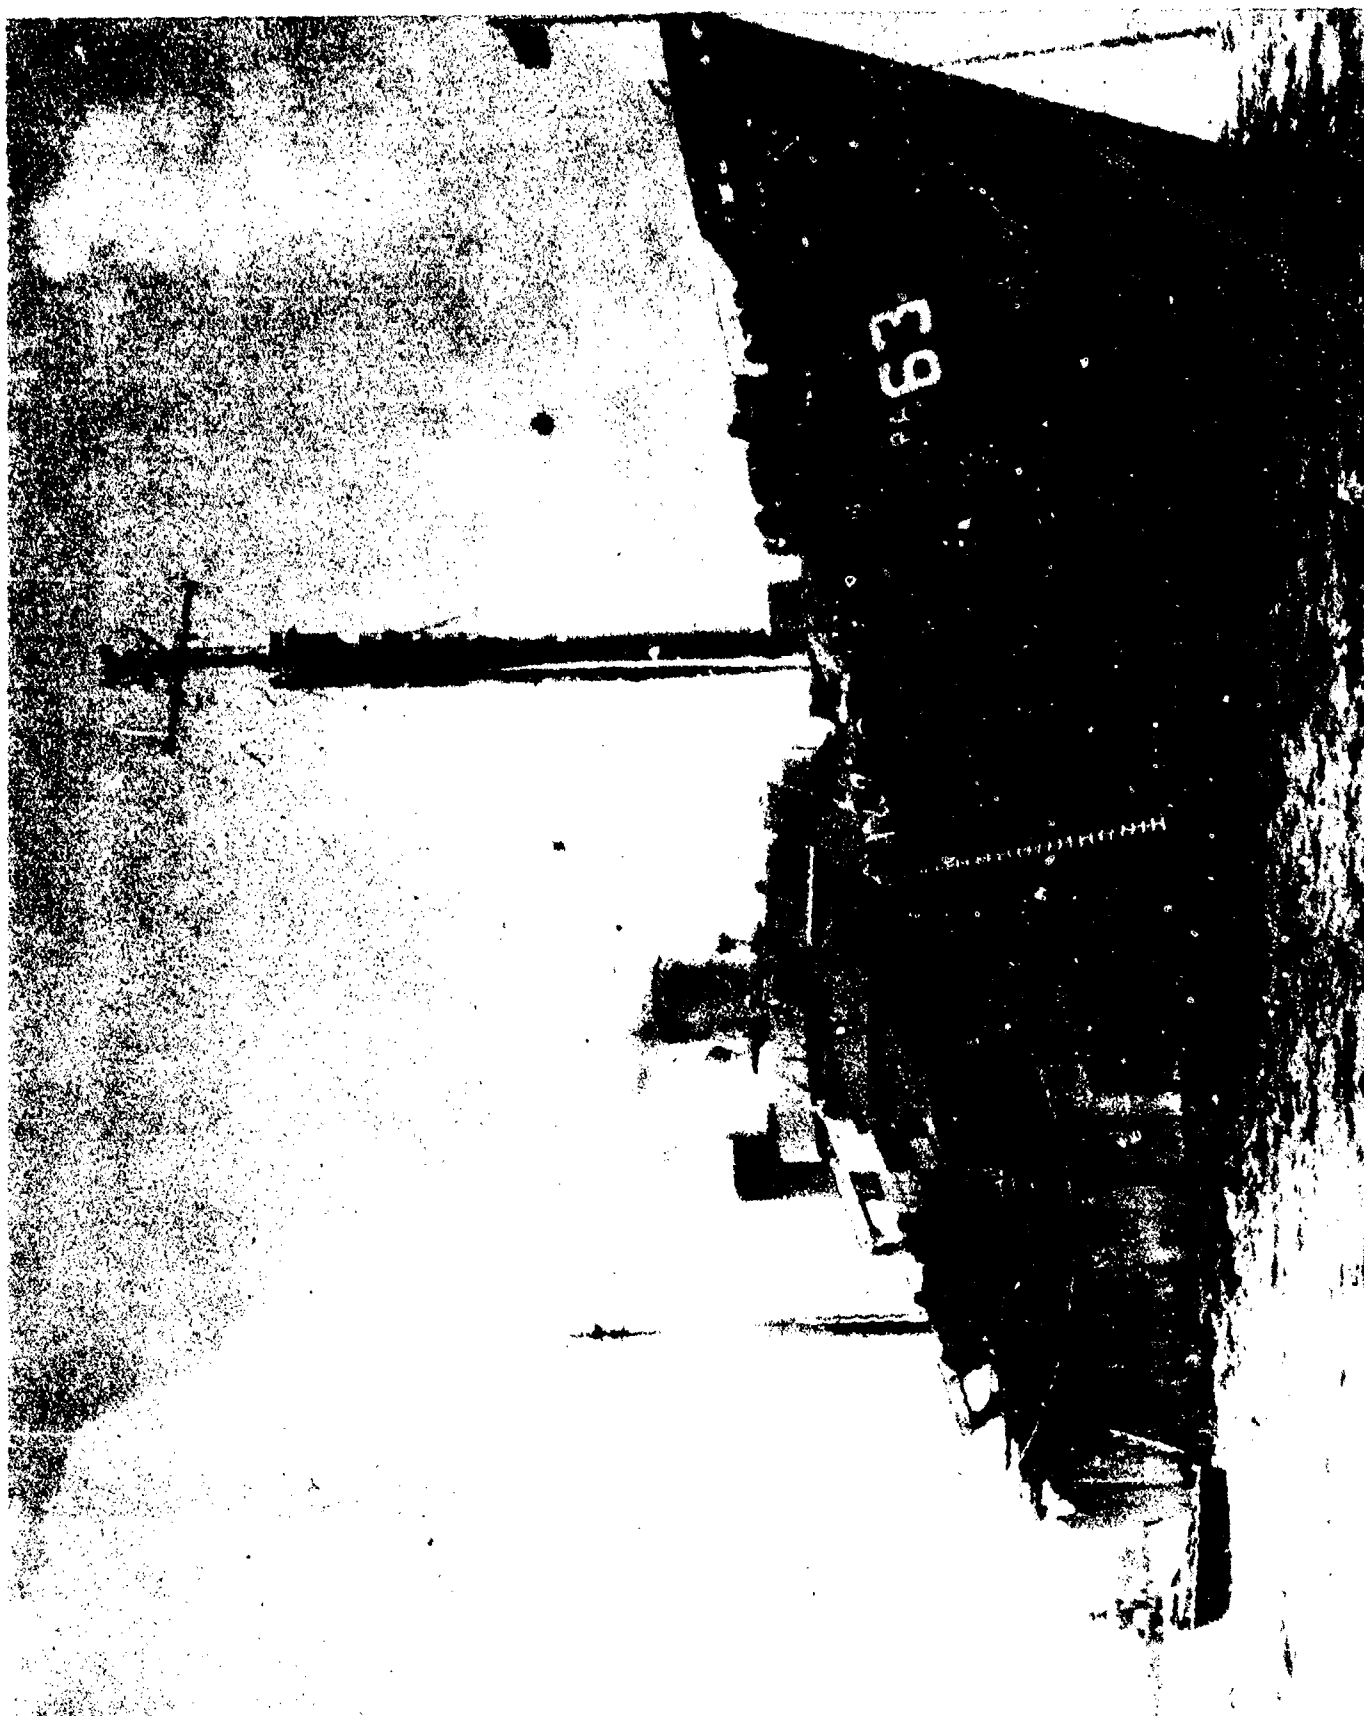
BB-CR-227-501-91. View off the starboard bow before Test B.

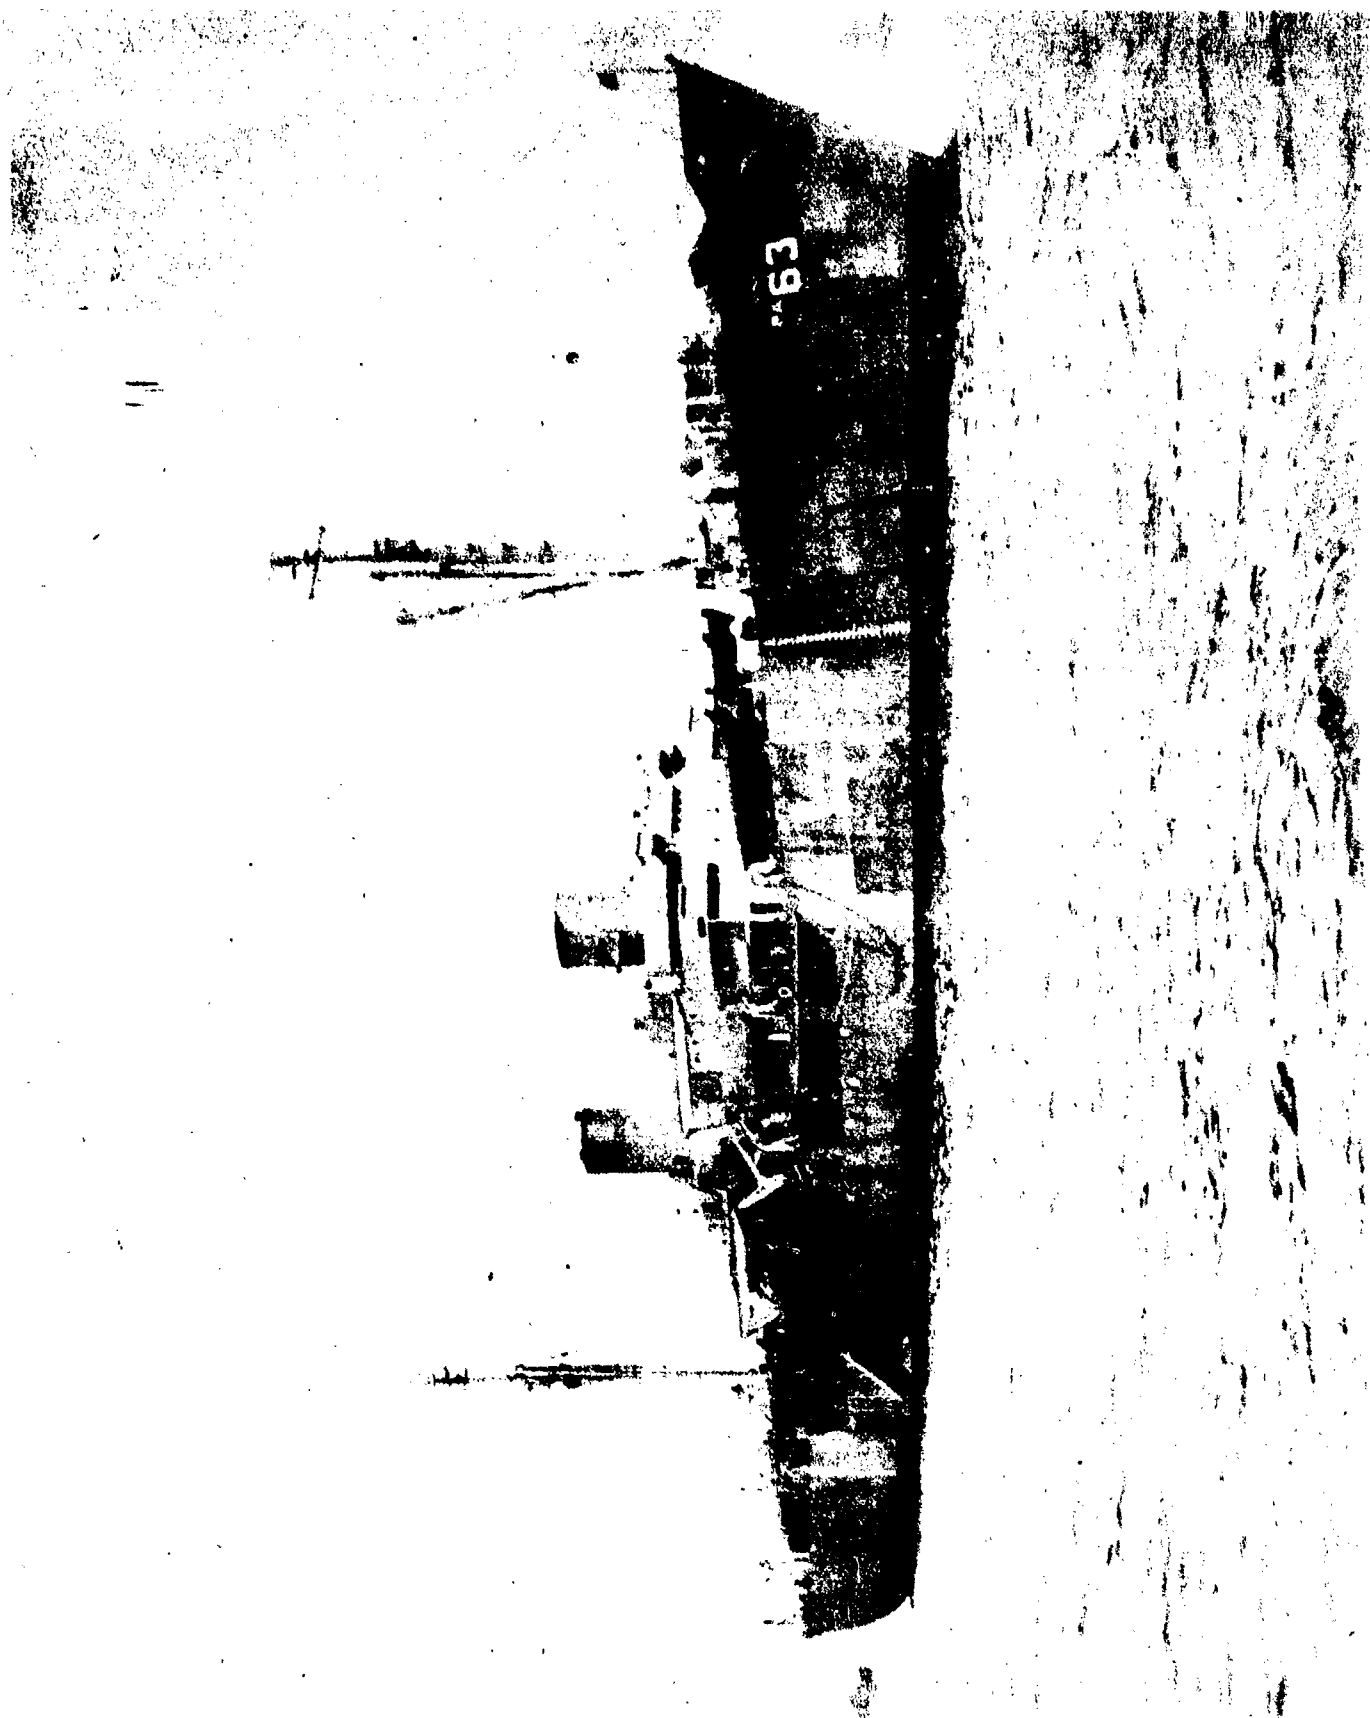
AB-CR-227-289-14. View off the starboard bow after Test B.
